Dein Plan Abdichtung:

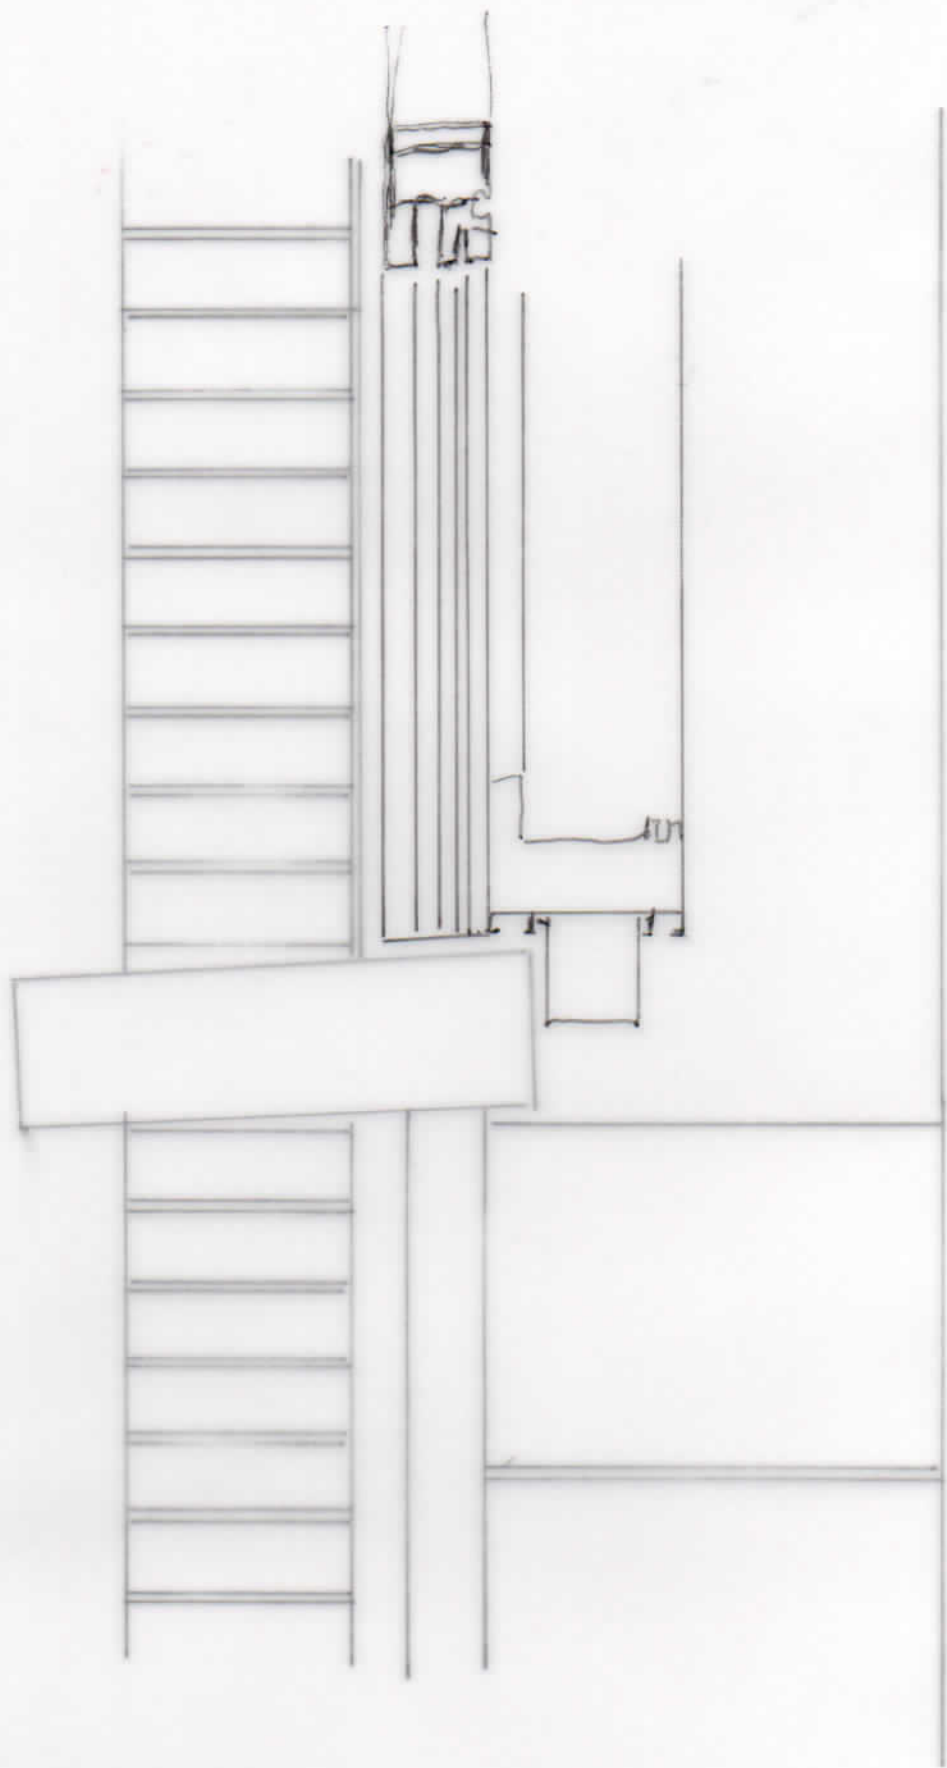
Dichtungs Lücke
Nut im
Blendrahmen:
1. Haftfläche zu klein
für Silicon.
2. Auflagefläche zu
klein für
Komprieband.

Abdichtung fehlt:

Vorschlag
Hier Zusätzlich
Komprieband
einlegen.
